## Rockfall Characterization and Structural Protection in the Siddhababa Section of Siddhartha Highway H10, Nepal

**Abstract:** Many national highways of Nepal are periodically facing the rockfall events, causing fatal accidents. The Siddhababa section of Siddhartha Highway is a lively example of an active rockfall zone where the highly steep slope geometry in combination to the unfavourable inclination of the rock joints with the road alignment primarily cause the rockfall. Recent accidents of a jeep and a bus have created much concern on rockfall in the area. But still, we do not possess any type of structural countermeasure to overcome this scenario. To address this problem, our study aims at firstly characterizing the rockfall in the area and then on proposing structural countermeasure as rockfall barriers, rock netting and rockshed, and assisted with rock bolting, based on simulation studies and analysis of the rockfall scenario in Rocscience Rocfall® program.

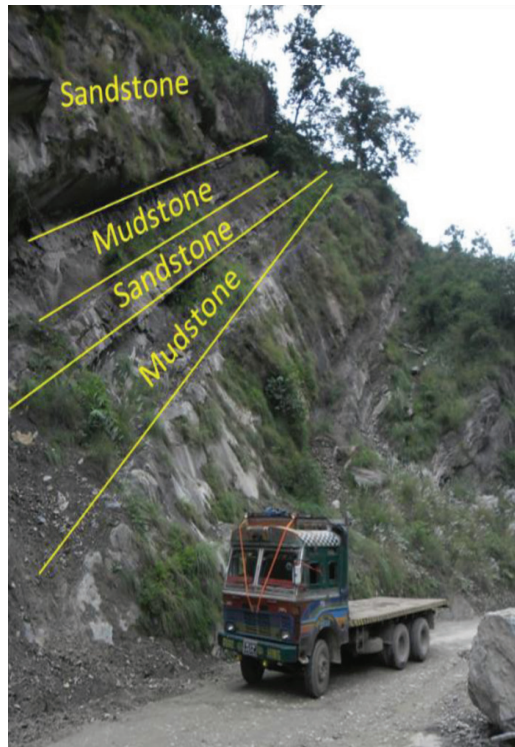
Fig. 4. The primary bedding is of sandstone and mudstone occurs at places; the mudstone bed erodes/wash out by rain then the overlying jointed rock loses support thus slips by plane failure

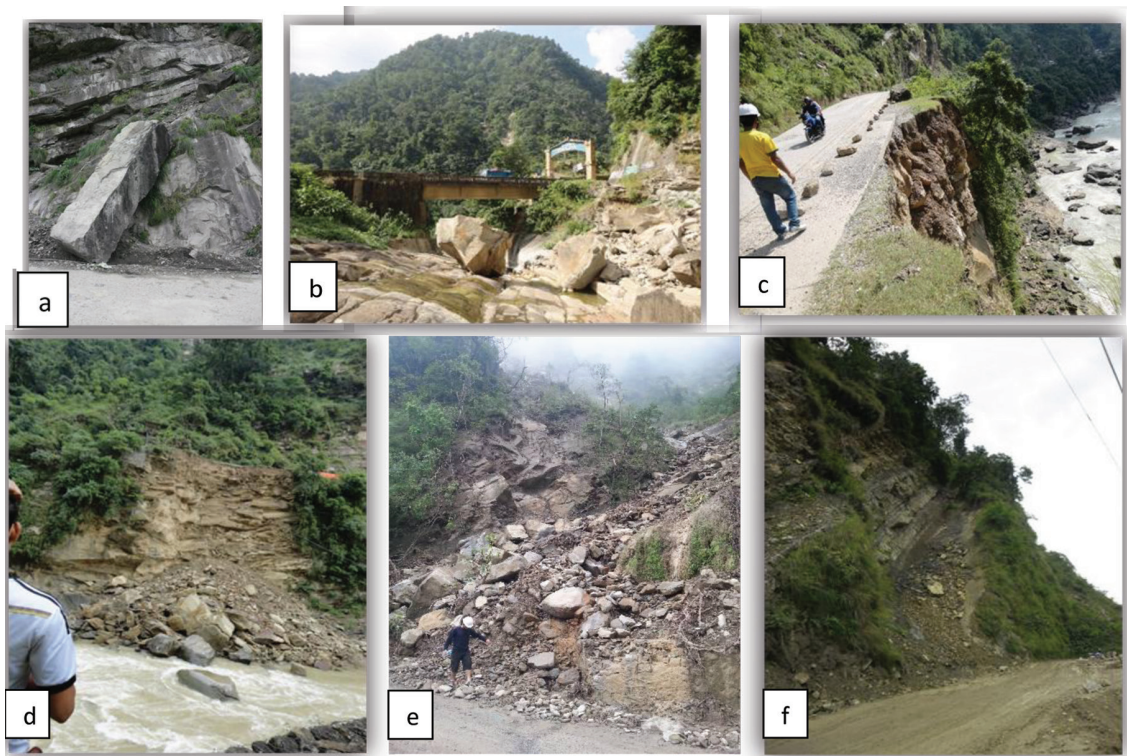
Fig. 5. Rock slope failure problem (a, b), Block failure type (c, d), Slope scar collapse and Debris flow (e & f).

Large blocks (average size.  $1\text{ m}^3$  to  $20\text{ m}^3$ ) splitting from the surface and falling on the road with mostly plane failure mechanism.

A portion of the rock slope fails by shear failure causing minor scale landslide leaving scar on the slope.

Many gully channels are being formed which are activated periodically during monsoons and carry large volume of debris at high speeds towards the road.

The recent rockfall of [18] is a slope scar type fall of approximately  $18\text{--}20\text{ m}^3$  volume and of [8] is Debris flow type fall.
